Report No. UT-06.02

**EFFECT OF STAY-IN-PLACE METAL
FORMS ON PERFORMANCE OF
CONCRETE BRIDGE DECKS**

Final Report

Brigham Young University
Department of Civil and Environmental
Engineering

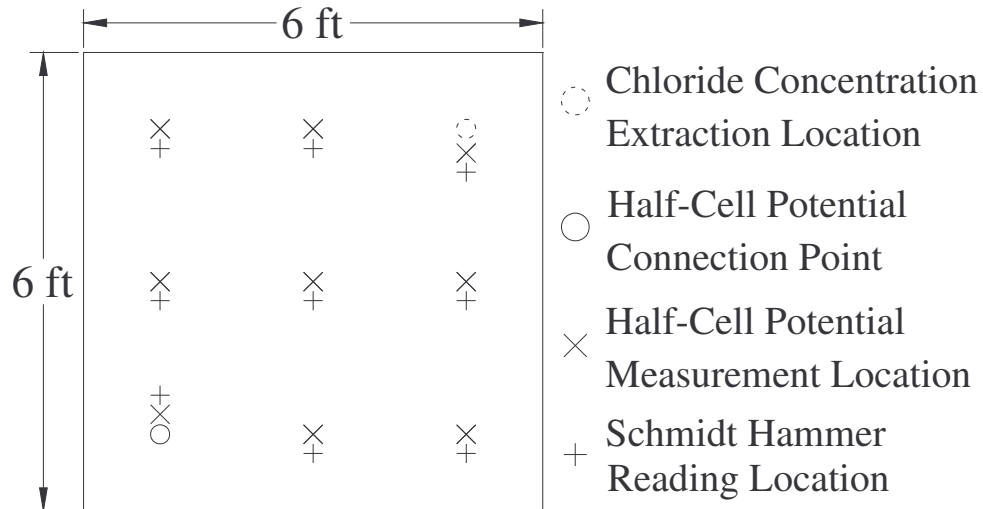
FIGURE 3.3 Testing layout.

The Schmidt hammer test provided a means of estimating the compressive strength of bare concrete decks and was used to measure the Schmidt rebound number at nine locations within each test area as shown in Figure 3.3. The test was not performed on the three decks surfaced with polymer overlays, however, because the surface of the concrete deck could not be exposed for evaluation. An average Schmidt rebound number was computed for each test location to estimate the concrete compressive strength. Higher compressive strengths generally correspond to greater resistance of the concrete to damage.

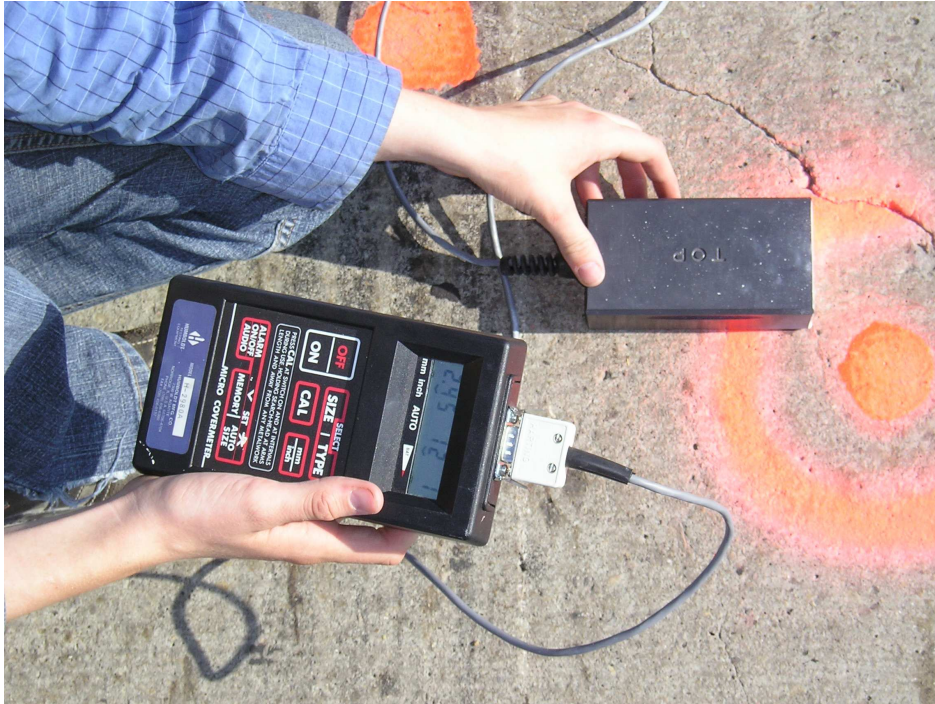
FIGURE 3.4 Use of cover meter to locate rebar.

As illustrated in Figure 3.4, a cover meter was used to establish the location of the rebar within each test area. Then, a hammer drill equipped with a 1-in.-diameter bit was used to expose the rebar at a single location to facilitate an electrical connection to the reinforcement. The drilling process stripped the rebar of its epoxy coating and

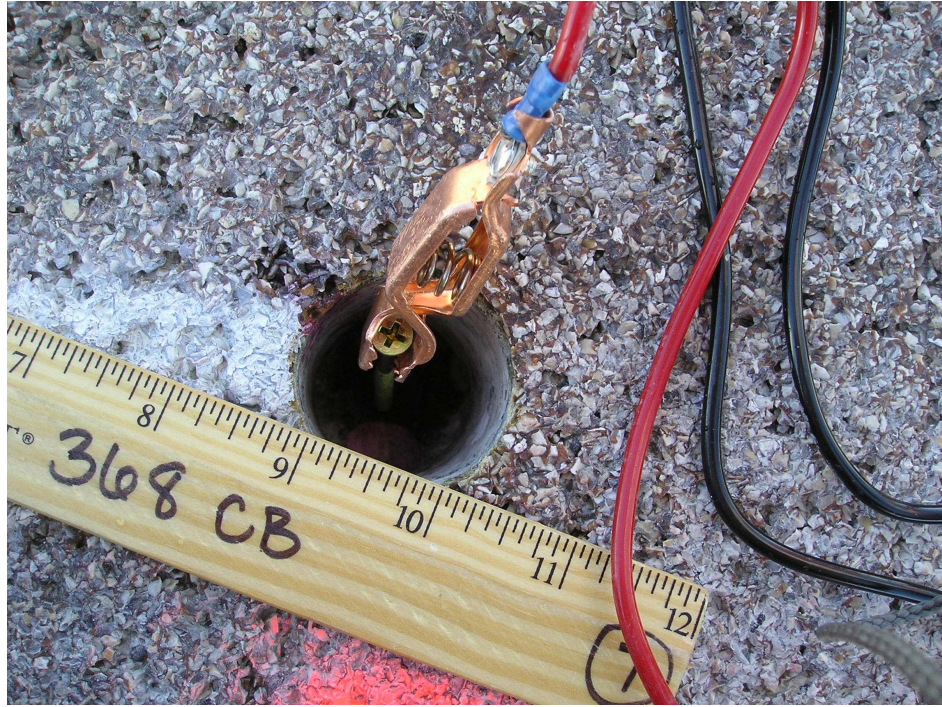
FIGURE 3.5 Connection of half-cell potential meter to rebar.

allowed an electrical lead from the half-cell potential meter to be directly connected to bright metal on the rebar as shown in Figure 3.5. Half-cell potential measurements were then obtained at the nine locations shown in Figure 3.3 using a copper-copper sulfate reference electrode (CSE), which was coupled to the concrete deck surface through a moistened sponge as depicted in Figure 3.6 (14). An average half-cell potential value was computed for each test location for assessment of the reinforcement corrosion activity. The depth of concrete cover over the rebar was also measured after the reinforcement was exposed.

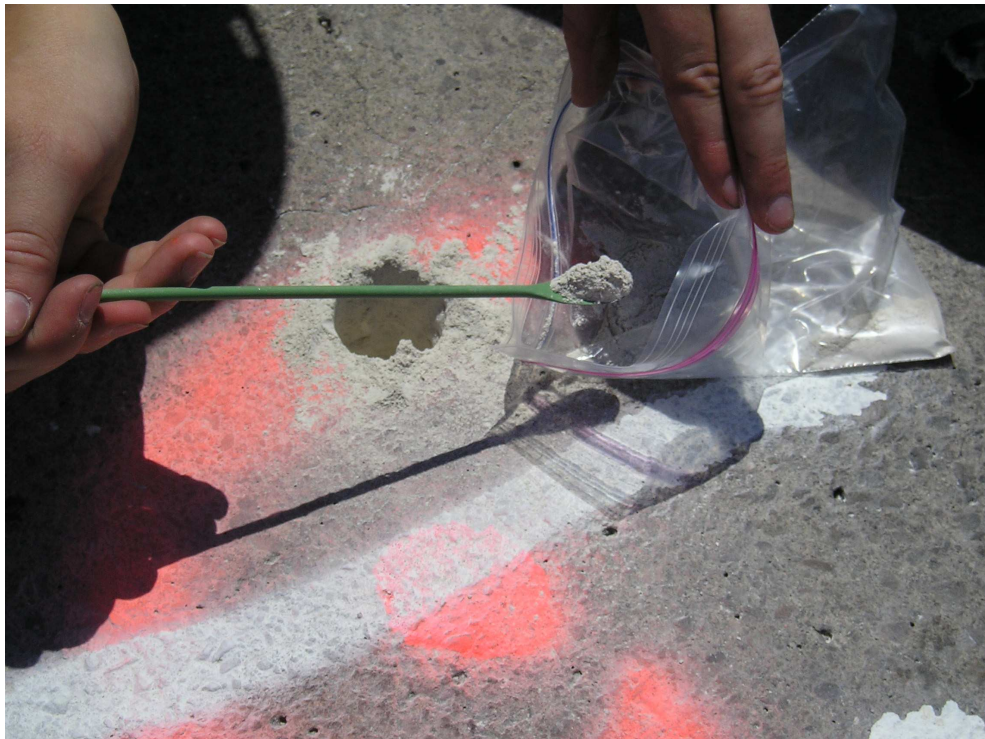
FIGURE 3.9 Collection of pulverized concrete samples.

After each lift was drilled, the pulverized concrete powder was manually removed from the test hole and placed into a plastic sample bag, as shown in Figure 3.9. The hole and drill bit were then cleaned using compressed air, the depth of the hole was measured using a digital micrometer, and the next lift was drilled.
